A Red Light Running (RLR) Photo Enforcement System was installed at the intersection of Ogden Avenue and Yackley Avenue on July 10, 2008, after finding limited success with other attempted measures to promote safer driving and improve compliance with traffic laws. As a condition of use, both Illinois law and the Illinois Department of Transportation require periodic statistical analyses / evaluations be conducted.

Ogden Avenue & Yackley Avenue Lisle, IL

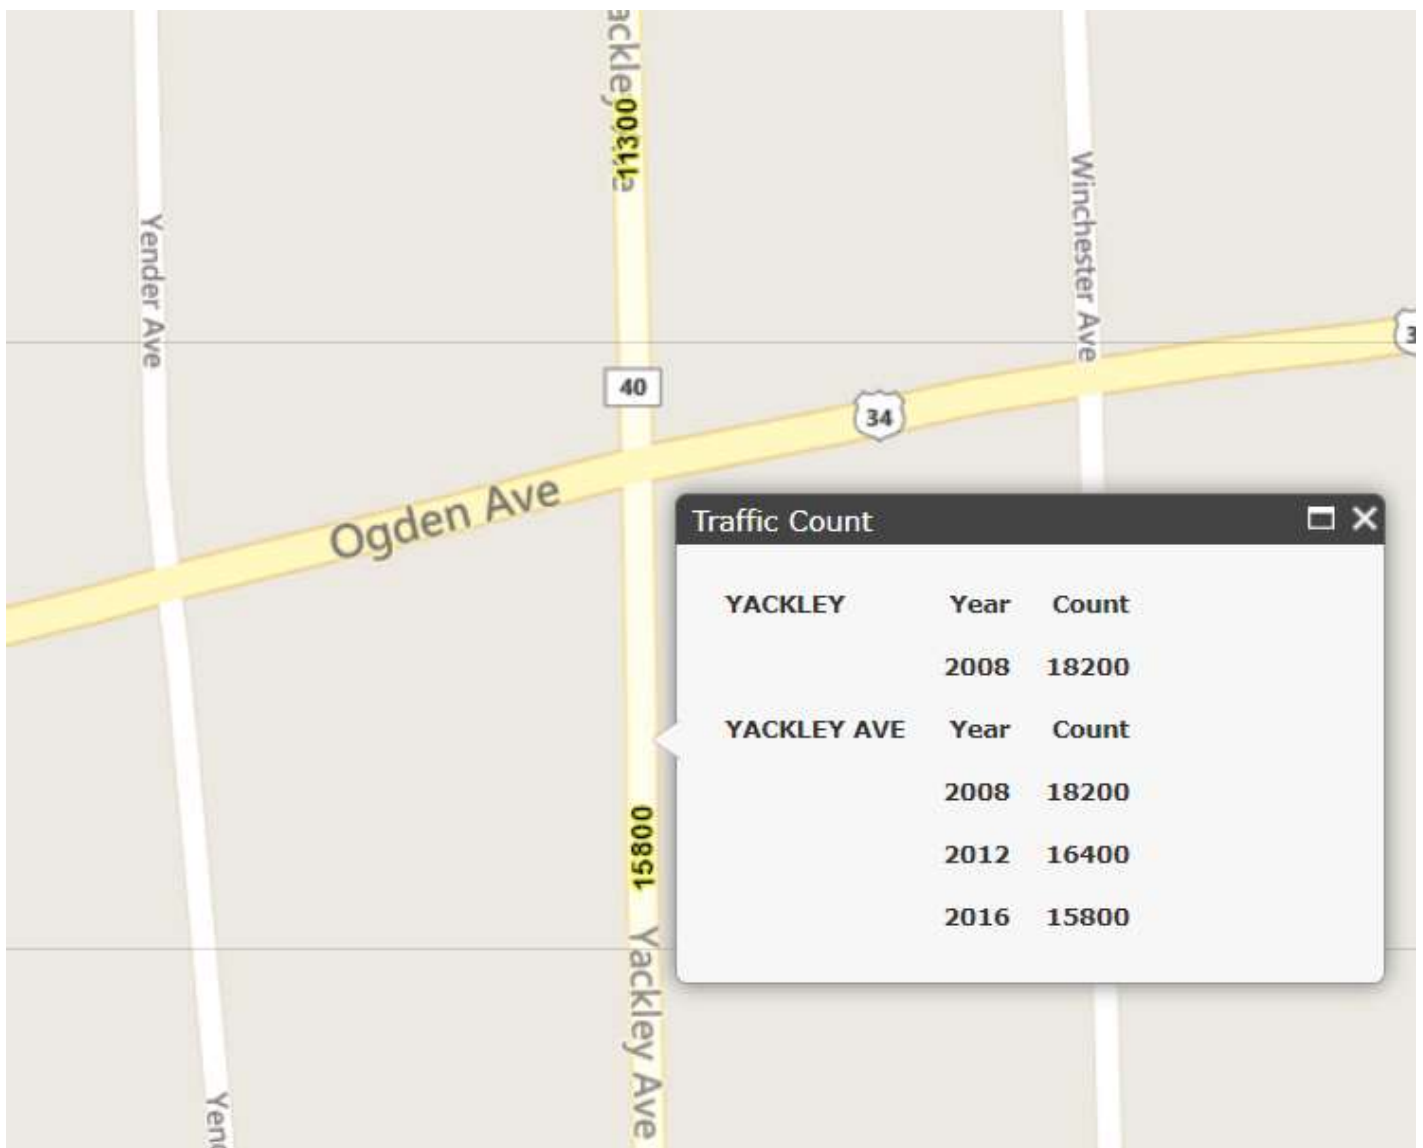
Ogden Ave. & Yackley Ave. (Northbound)

Data was obtained from the Illinois Department of Transportation's website
www.gettingaroundillinois.com.

- 15,800 (2016)

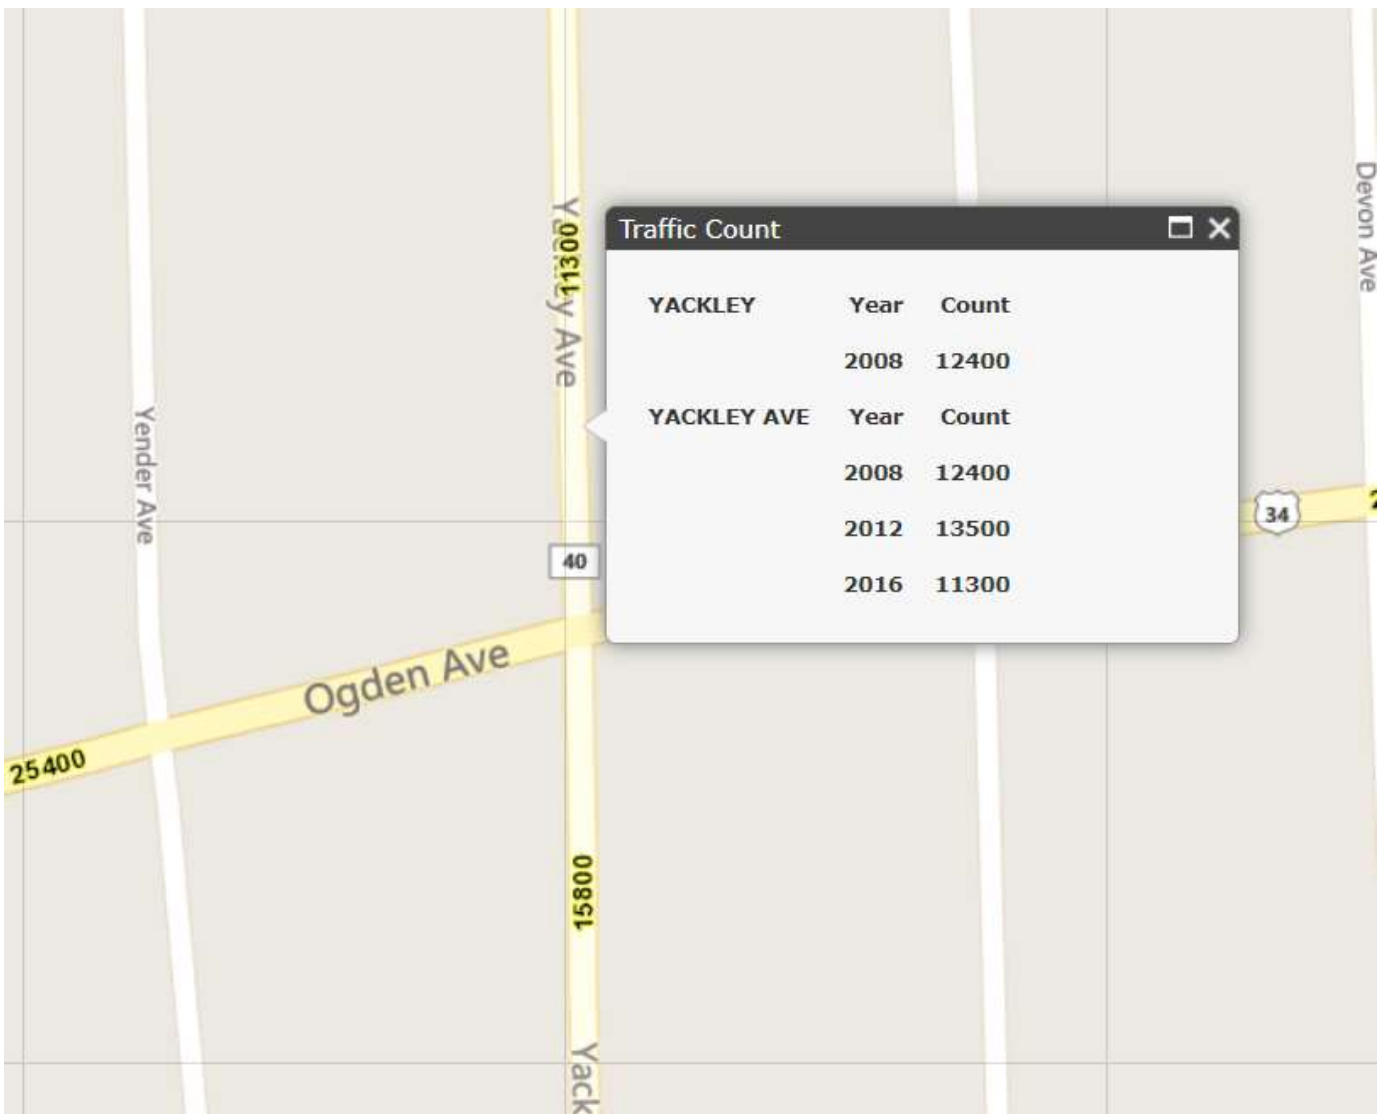
Ogden Ave. & Yackley Ave. (Southbound)

Data was obtained from the Illinois Department of Transportation's website www.gettingaroundillinois.com.

- 11,300 (2016)

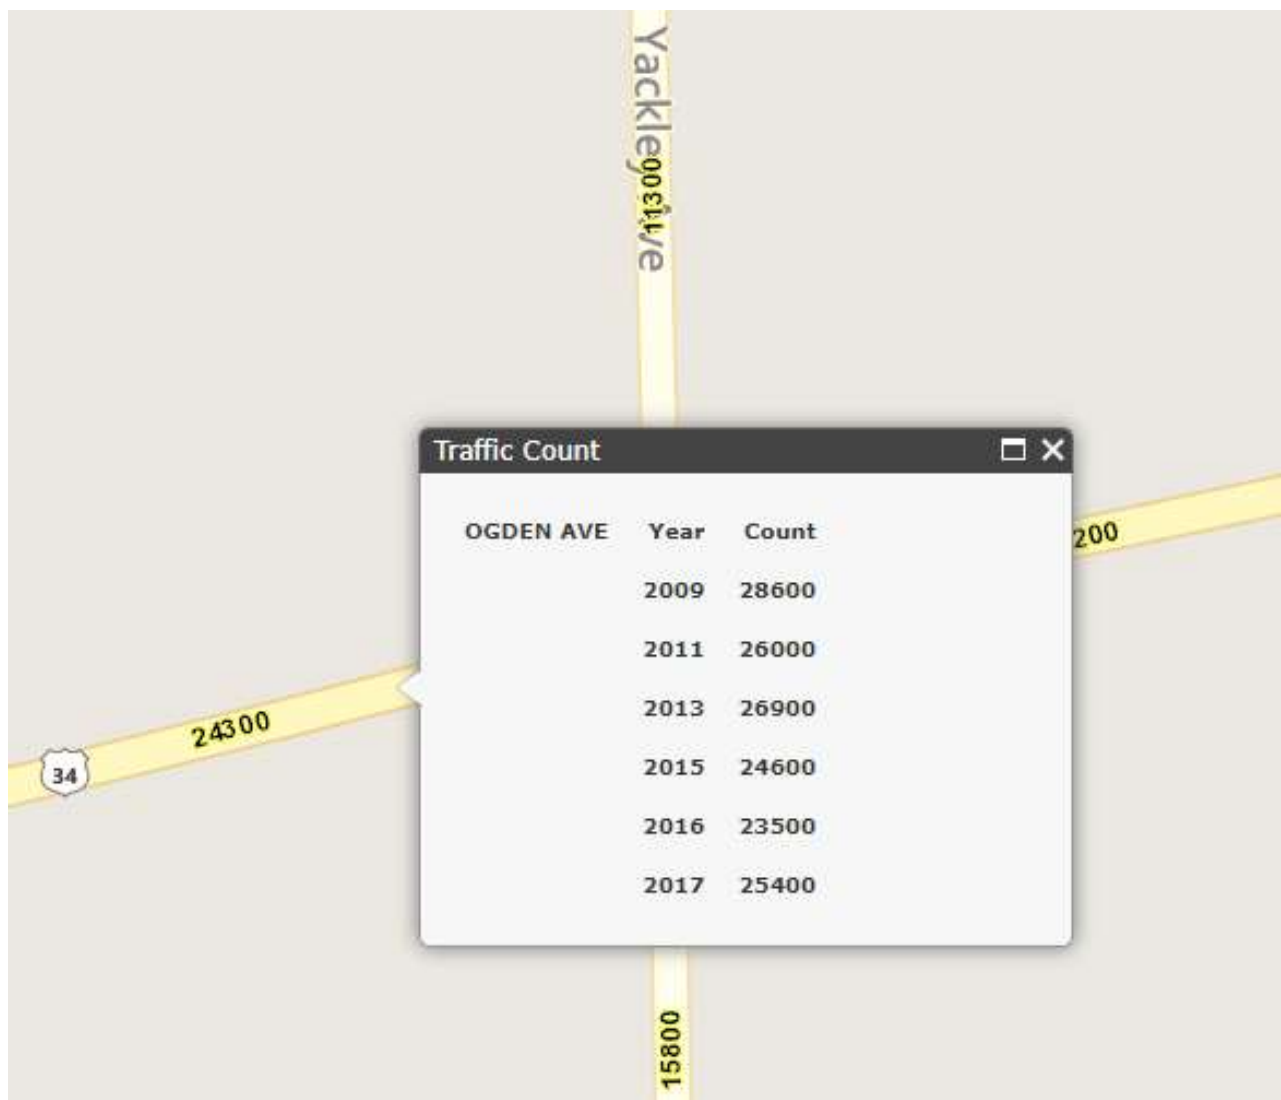
Ogden Ave. & Yackley Ave. (Eastbound)

Data was obtained from the Illinois Department of Transportation's website www.gettingaroundillinois.com.

- 24,300 (2019)

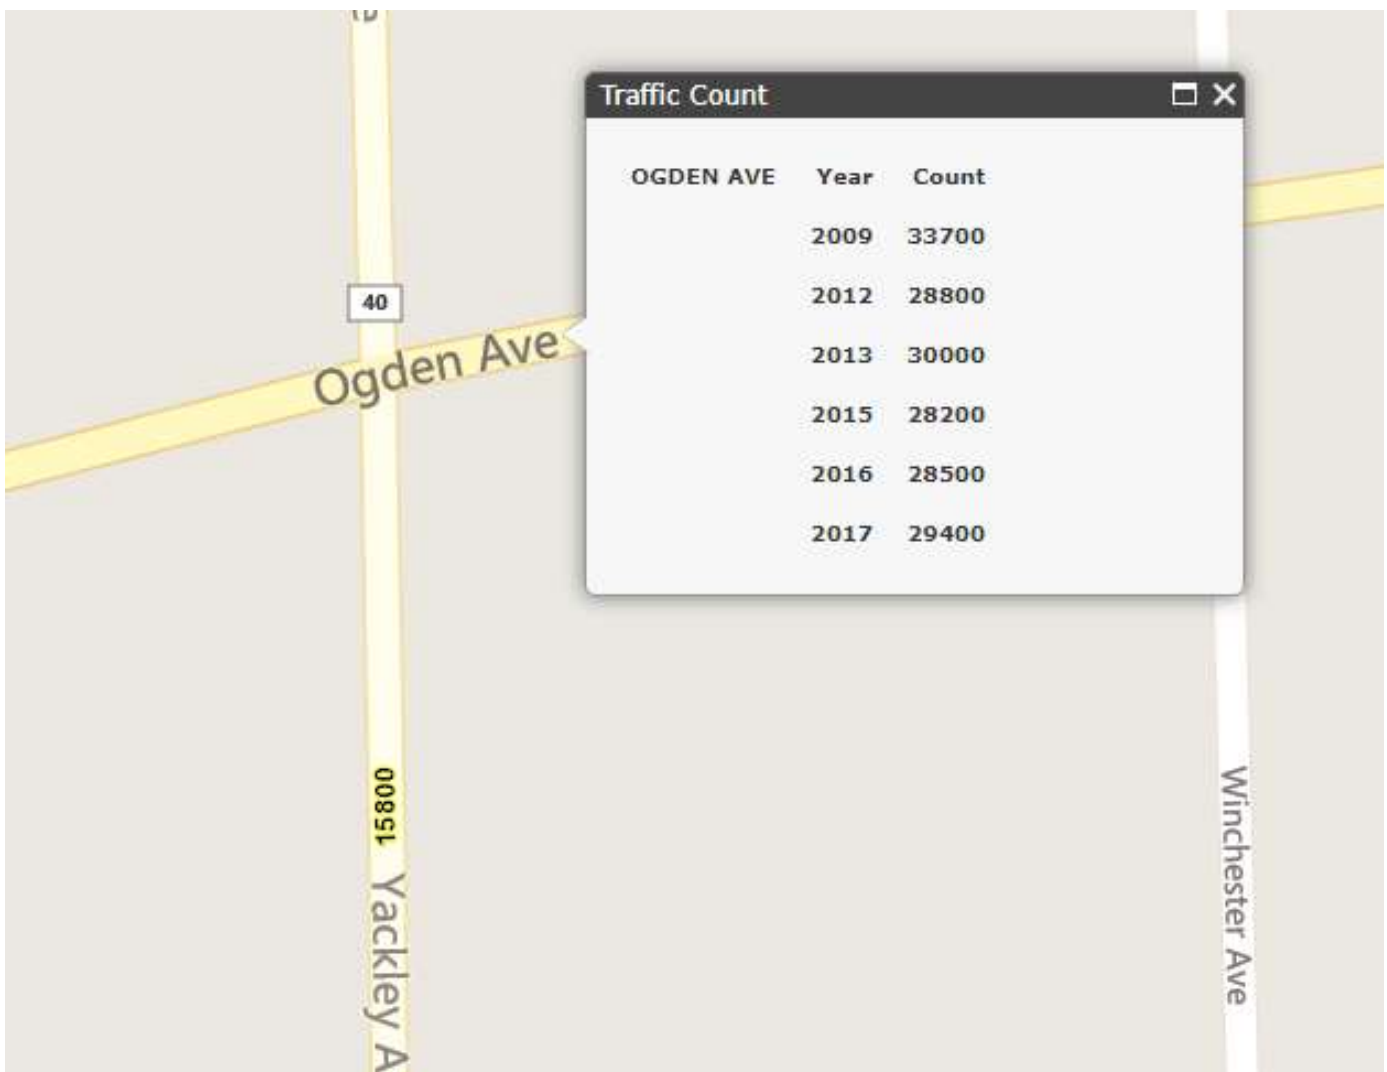
Ogden Ave. & Yackley Ave. (Westbound)

Data was obtained from the Illinois Department of Transportation's website
www.gettingaroundillinois.com.

- 27,200 (2019)
